Force Based Condition Monitoring of Railway Infrastructure

Abstract: A South African transportation company has implemented a force based condition monitoring system to reduce the infrastructure / vehicle interaction life cycle costs of a railway infrastructure. It has been demonstrated that force measurements can be used to successfully prevent catastrophic failures in the Overhead Track Equipment from occurring and recurring. Opsens' OSP optical strain gages were used for the measuring system because they suit perfectly to this harsh environment. These sensors provide accurate and repeatable measurements in electromagnetic interference, mechanical vibrations and in adverse weather conditions.

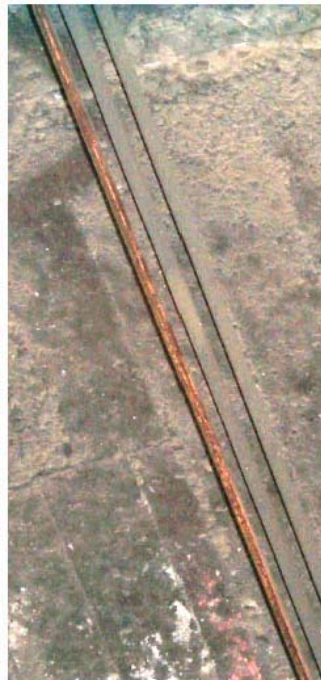
Figure 1: Scrape marks on contact wire, caused by pantographs bouncing due to low tensioned contact wire

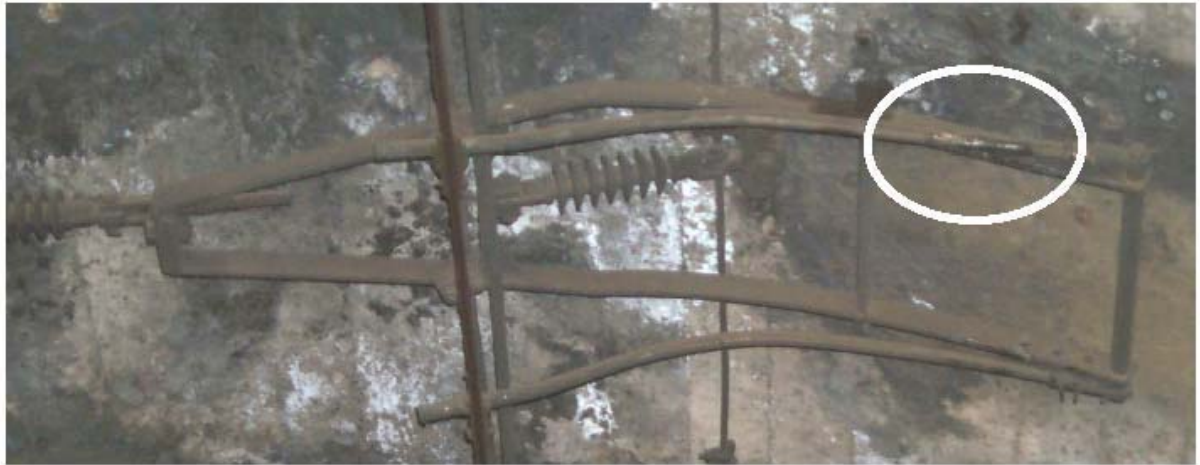
Figure 2: Cause of vertical impact force due to pantograph hitting cross-span. This was due to low tensioned OHTE causing abnormally high contact wire uplift.
